Testing and Failure Mechanisms of Ice Phase Change Material Heat Exchangers

Paragon Space Development Corporation, Houston, Texas, 77058

NASA-Johnson Space Center, Houston, Texas, 77058

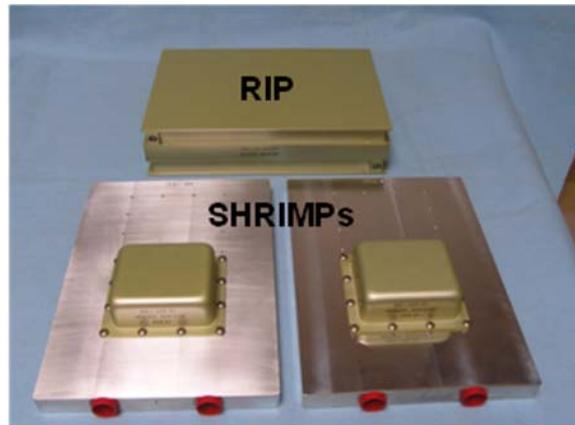
In previous testing², a series of water PCM test articles were procured and tested at JSC for the purpose of better understanding and documenting the technical issues associated with the expansion of water within a PCM heat sink. One of these test articles was the Replicative Ice PCM (RIP), owing its name to the fact that it replicates the 450 kJ latent energy storage capacity of the baseline wax PCM unit. Each of the two other test articles was a Small Heatsink of Replicative Ice Material for Phase change (SHRIMP). These smaller units had a 40 kJ latent energy storage capacity. Both SHRIMP's and the RIP included a 20% air gap for the purpose of accommodating the expansion of water upon freezing. A photograph of these test articles is shown in Figure 3.

Figure 3. RIP and SHRIMP hardware.

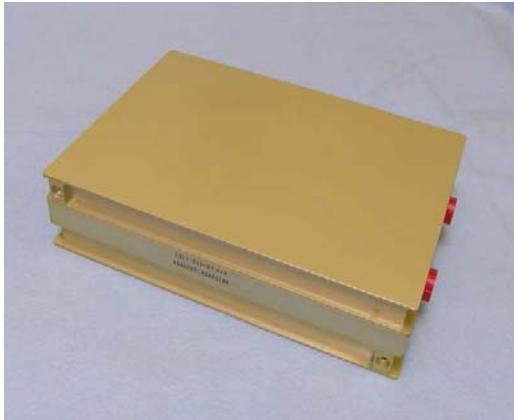
Figure 10: Heat Sink 04 (HS04)

HS04 (see Figure 10) is similar to the original RIP on a CP-30 coldplate, except that unlike the original RIP, HS04 has the Gen 2 interstitial arrangement of Figure 4-B. This unit was developed to compare to the original RIP and SHRIMP 2. HS04 can be compared to RIP in the same way that SHRIMP-2 was compared to SHRIMP-1, with the only difference in the comparison being the interstitial arrangement. Likewise, HS04 can be compared to SHRIMP-2 in the same way that RIP was compared to SHRIMP-1, with the only difference in that comparison being the size of the unit.

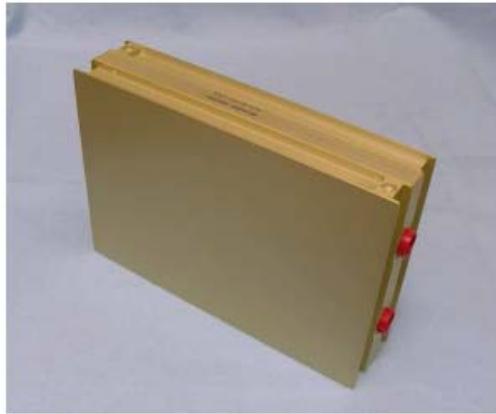
Figure 12: HS04 on Edge

Due to the size and interstitial configuration of HS04 special handling instructions were followed. HS04 has 47 straight fins that span its width with carbon fibers (carbon velvet) on both sides as shown in Figure 11. Each fin has notches on both ends and in the center to connect the fin cavities with each other to allow the unit to be properly charged with water during assembly. To ensure a uniform distribution of water before testing, HS04 was first placed on edge as shown in Figure 12 to allow the PCM to pool along the edge of the heat sink. After hours of being on edge, HS04 was rolled back to the flat position allowing the PCM to redistribute uniformly between the fins. This process was done before HS04 was placed in the testing location and repeated once it was removed.

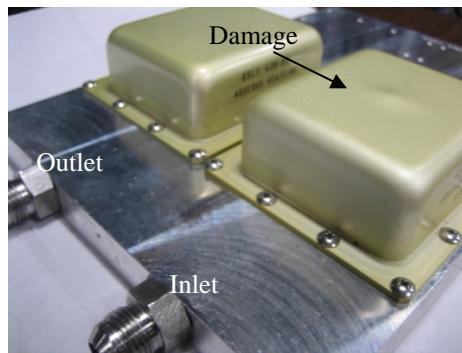
Figure 16: HS02 Damage

HS02 failed between test cycles 11 and 25 in the favorable gravity position as evidenced by the appearance of a bulge in the center of the SHRIMP on the fluid inlet side. It is not apparent which test cycle HS02 failed on because an inspection was not done after a given number of back to back test cycles. Since failure was not present at the inspection done after test cycle 10, it was decided to continue running through test cycle 25 without another inspection. In the adverse gravity test position, HS02 failed on the first cycle, with the existing bulge growing in size and a new bulge appearing on the other SHRIMP as well.

Failure in the adverse gravity position was expected. However, failure in the favorable orientation was unexpected since SHRIMP-1 showed no damage in the favorable orientation during last year's testing. One hypothesis for any damage that did occur with HS02 was that the SHRIMP's would fail near the outsides, not in the center, towards the no-flow areas of the coldplate. Instead, the SHRIMP on the fluid inlet side failed in the center (see Figure 16) and the SHRIMP on the fluid outlet side showed no sign of damage until it was tested in the adverse gravity position.

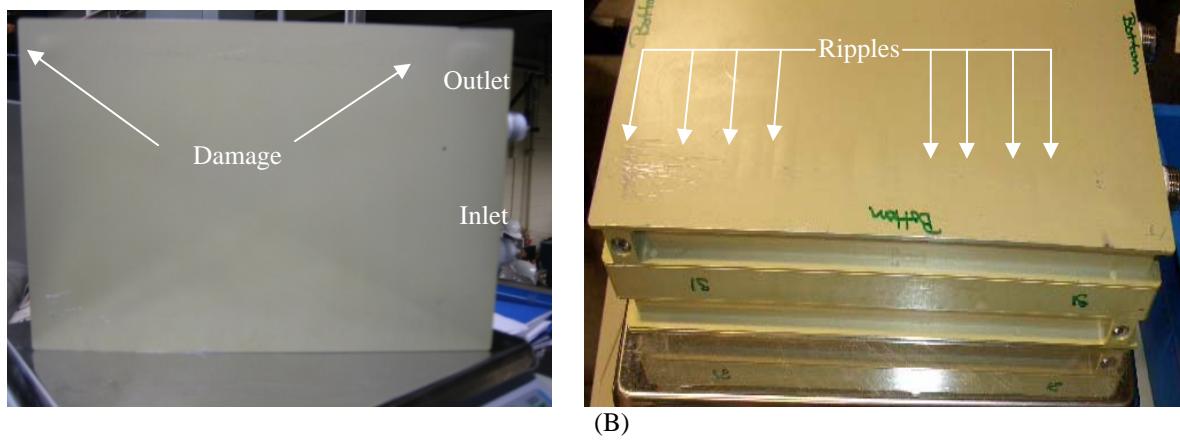
Figure 17: HS04 Damage. (A) First adverse cycle. (B) After inlet and outlet switched.

On the bottom side, a bump was present after the first test cycle near the fluid outlet (see Figure 17). Damage had been anticipated to occur on the bottom side of HS04, but not necessarily so early into the test cycles due to the Gen 2 interstitial configuration. It was postulated that damage may have happened on the bottom fluid outlet side because HS04 was placed on the fluid outlet edge to allow the PCM to pool towards that edge before it was flipped back over to distribute the PCM evenly between the fins (refer to the aforementioned special handling instructions). Placing HS04 on the fluid outlet edge may have allowed the fluid outlet side to be concentrated with more of the PCM causing damage when frozen. To test this assumption, HS04 was placed on side 1, also known as the good side (FOGS), to see if damage would occur on the fluid inlet side. After the next five test cycles, there was no sign of damage on the fluid inlet side. Also, more damage was not present when HS04 was put through back to back test cycles although it was postulated that damage may occur since HS04 was not placed on its side after each test cycle to allow the PCM to redistribute evenly. It may have just been that two back to back cycles were not enough to significantly affect the distribution of the water.

Based on these observations, coupled with the location of bulges in RIP toward the fluid outlet side from last year's testing, a hypothesis was developing that the water PCM may be getting pushed generally from the inlet to the outlet side of the heat sink due to directional freezing from the coolant temperature gradient as it flows through the coldplate. To further investigate this hypothesis, 5 cycles were run with HS04 with the fluid inlet and outlet switched HS04 using flex hoses, as shown in Figure 18. More damage occurred in the form of ripples along the new

outlet side (previously the inlet side) of the heat sink. This observation seems to support the hypothesis of water being pushed from inlet to outlet due to directional freezing.

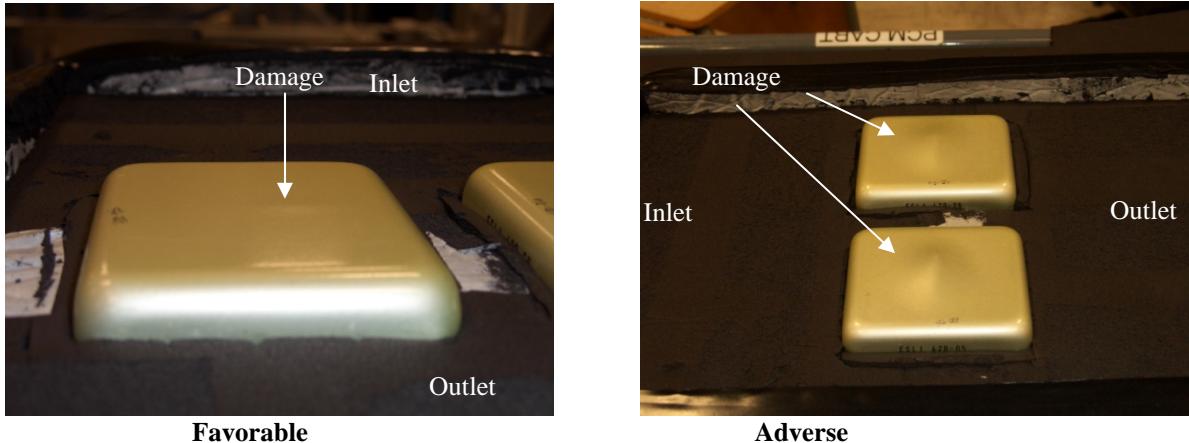
Figure 19: HS03 Damage

HS03 failed in the favorable gravity test position after cycle 22. It was anticipated that the SHRIMP's would show signs of damage on the back end, closest to the fluid outlet, since the PCM would start to freeze towards the fluid inlet and move back towards the fluid outlet side (assuming a uniform contact resistance between each SHRIMP and the coldplate). Contrary to this hypothesis, the SHRIMP on the fluid inlet side of HS03 failed towards the center in the favorable gravity position as shown in Figure 19. Once flipped to the adverse gravity position, both SHRIMP's failed after the first test cycle.

The shape of the damage present on HS03 in the adverse gravity position differed from the damage seen on the other heat sinks. Damage to the other heat sinks formed in a circular shape. Once turned to the adverse gravity position bumps usually got wider and some increased in height, but they remained in a generally circular shape. However, the bumps present on HS03 formed into an elliptical shape when flipped to the adverse gravity position. They got wider in the direction perpendicular to the coldplate flow path, as shown below in the right side of Figure 19.

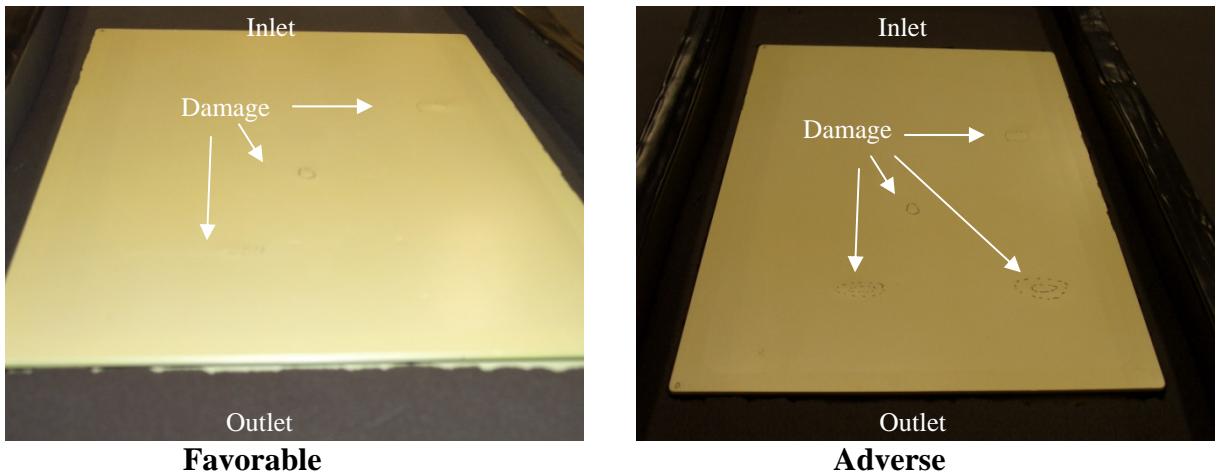
Figure 20: HS01 Damage

HS01, the half RIP heat sink, failed after test cycle two in the favorable gravity test position as shown below in Figure 20. It had been anticipated that any bumps would have occurred toward the outlet side of the heat sink due to directional freezing resulting from the coolant temperature gradient from the inlet to the outlet of the coldplate. However, the location of the bumps observed on HS01 seemed to be randomly distributed. When tested in the adverse orientation, two of the bumps that were formed in the favorable test position slightly expanded in width and an additional bump was formed.
